# Springs Radiator Services (Pty) Ltd

## FREIGHTLINER RADIATOR FAILURES

Because of an inordinate number of failures on Freightliner radiators, an extensive investigation was started. Three major areas of concern were found.

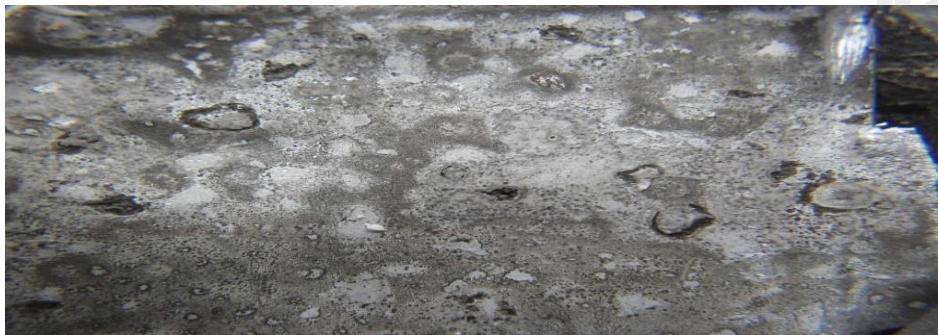
Freightliners are prone to electrolysis, because they do not earth the truck to the same degree that other truck manufacturers do. In tubes that were cut open the electrolysis corrosion pitting marks are clearly visible. In correspondence that we managed to get hold of, certain improvements are recommended to address this problem.

- Additional earth cable equal in gauge to the battery (+) cable must be attached to the starter (-) terminal. This will form the common earth connection.

- From the cab electrical earth point an insulated 12 gauge electrical wire must be taken to the common point at the starter (-) terminal.
- All existing earthing connections must be removed and cleaned to bright metal condition. When reinstalling the earth connections aluminium wiring conductive grease must be applied to contact points. Earth connections must also be sprayed with an electrical insulating spray to keep out dirt and water.

- Whenever a battery is replaced and (+) cable connectors are cleaned, all earth connections must be cleaned as per the above instructions.
- **Do not fix an earth strap to the radiator. This will force a stray current through the radiator and aggravate the problem.**

- The front frame aluminium plate is used for earthing of lighting and other electrical attachments. The aluminium plate must be sanded clean to remove any aluminium oxide and then connections must be covered with aluminium wire grease and sprayed with electrical insulating spray. An earth wire must be attached from the frame to the cab earthing connection on the left front chassis frame rail, using aluminium wire grease and insulating spray.

- The above should form part of the regular maintenance schedule of vehicles.

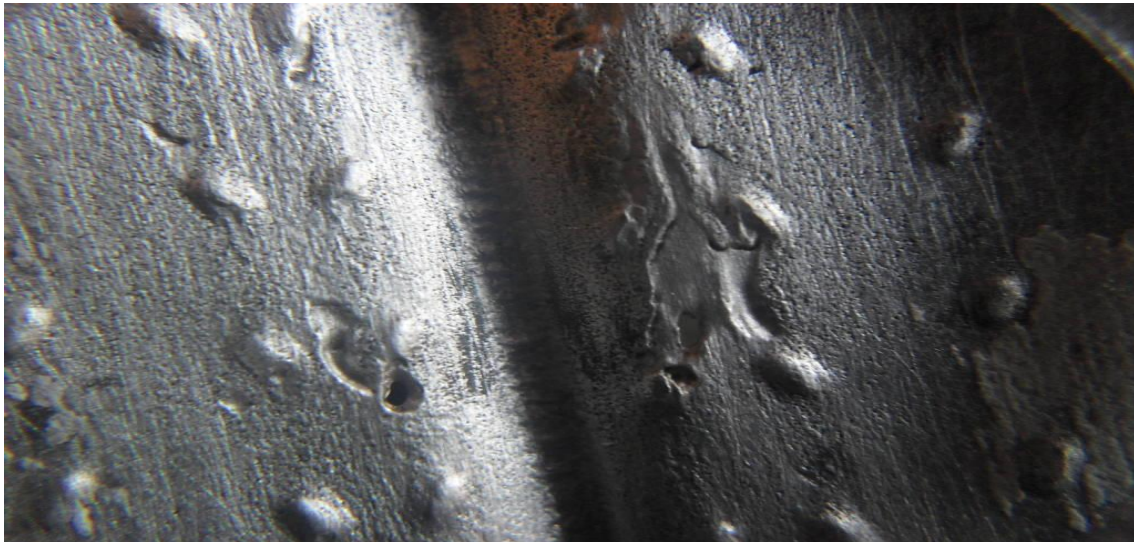
The aluminium Freightliner radiators from USA use a dimpled tube to improve water turbulence. Because these dimples stand proud on the inside of the tube, they are very susceptible to erosion if the cooling system is dirty. Dirt swirling down the tubes scours the raised dimples away till a leak has sprung.

Aluminium oxide, the end product of corrosion/electrolysis is an abrasive used for making sanding paper. If there is Aluminium oxide in the system this will aggravate the erosion of the dimples in the tubes.
